**Subject: Removal Action Report
Dead Creek Sediment Removal Site
Sauget, St. Clair County, Illinois
EPA Contract No. 68-W-00-129
TDD No. S05-0104-010**

REMOVAL ACTION REPORT
DEAD CREEK SEDIMENT REMOVAL
SAUGET, ST. CLAIR COUNTY, ILLINOIS

**REMOVAL ACTION REPORT
DEAD CREEK SEDIMENT REMOVAL
SAUGET, ST. CLAIR COUNTY, ILLINOIS**

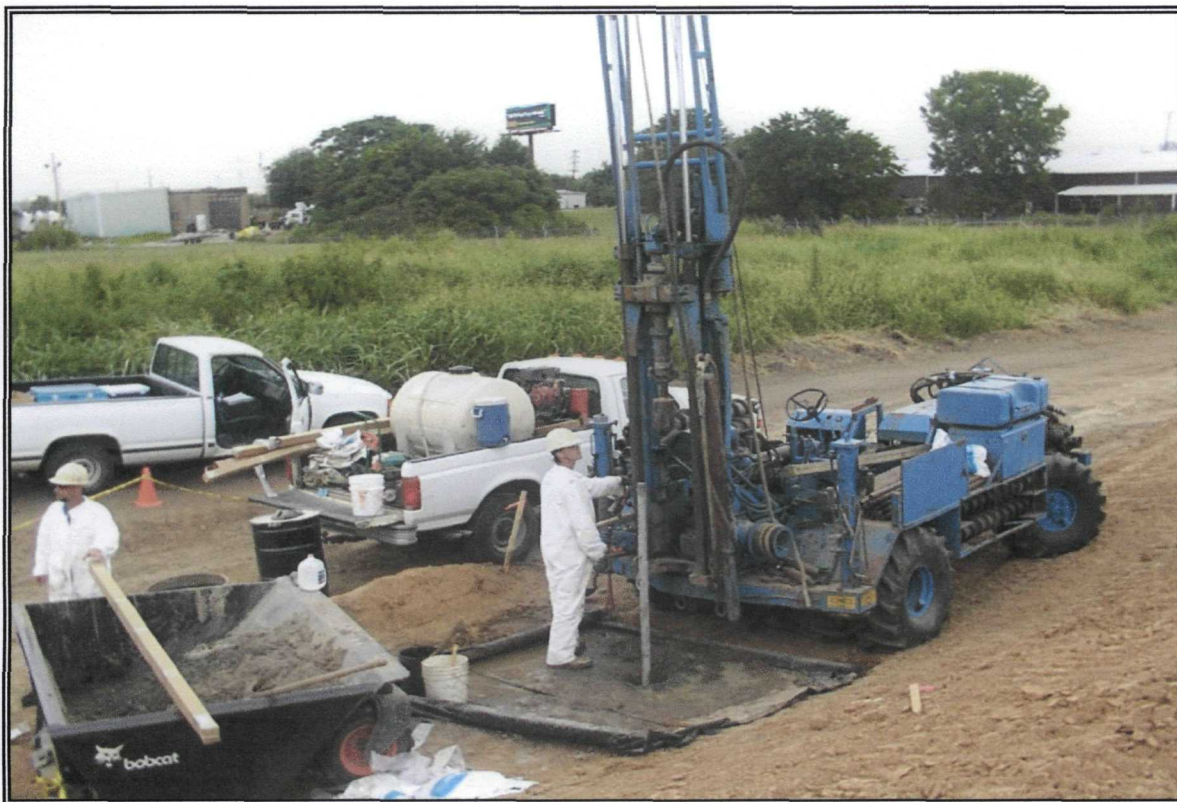
OFFICIAL PHOTOGRAPH NO. 26
U.S. ENVIRONMENTAL PROTECTION AGENCY

Subject: Installation of a 25-foot deep groundwater monitoring well near the northwest corner of the cell.

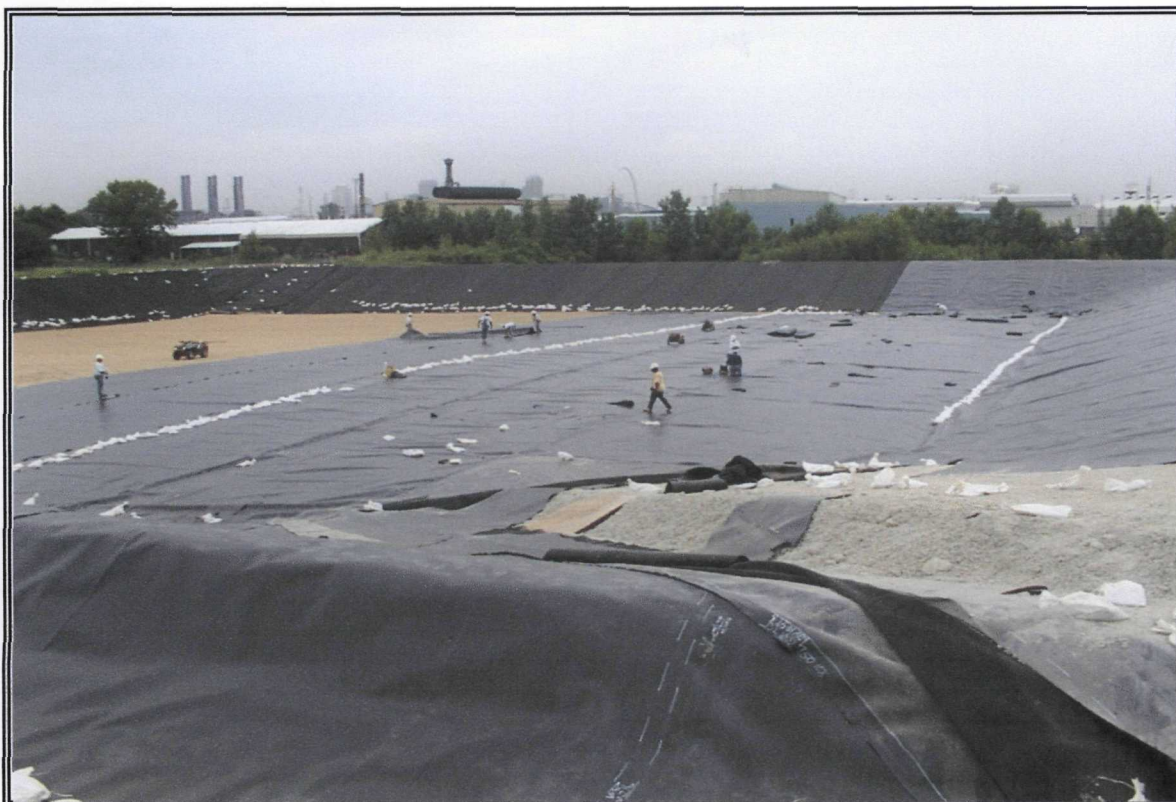
OFFICIAL PHOTOGRAPH NO. 27
U.S. ENVIRONMENTAL PROTECTION AGENCY

Subject: Covering the cell with geomembrane.

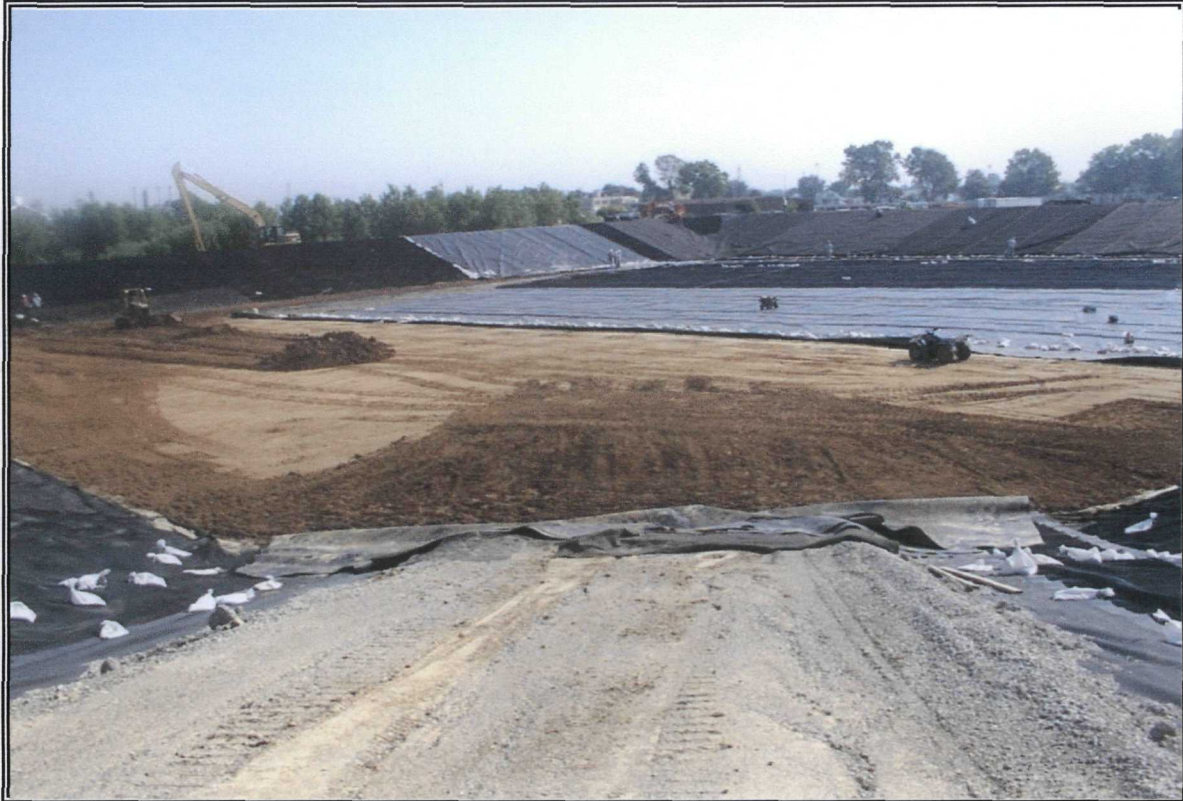
OFFICIAL PHOTOGRAPH NO. 28
U.S. ENVIRONMENTAL PROTECTION AGENCY

Subject: Cell construction showing various layers of the primary liner.

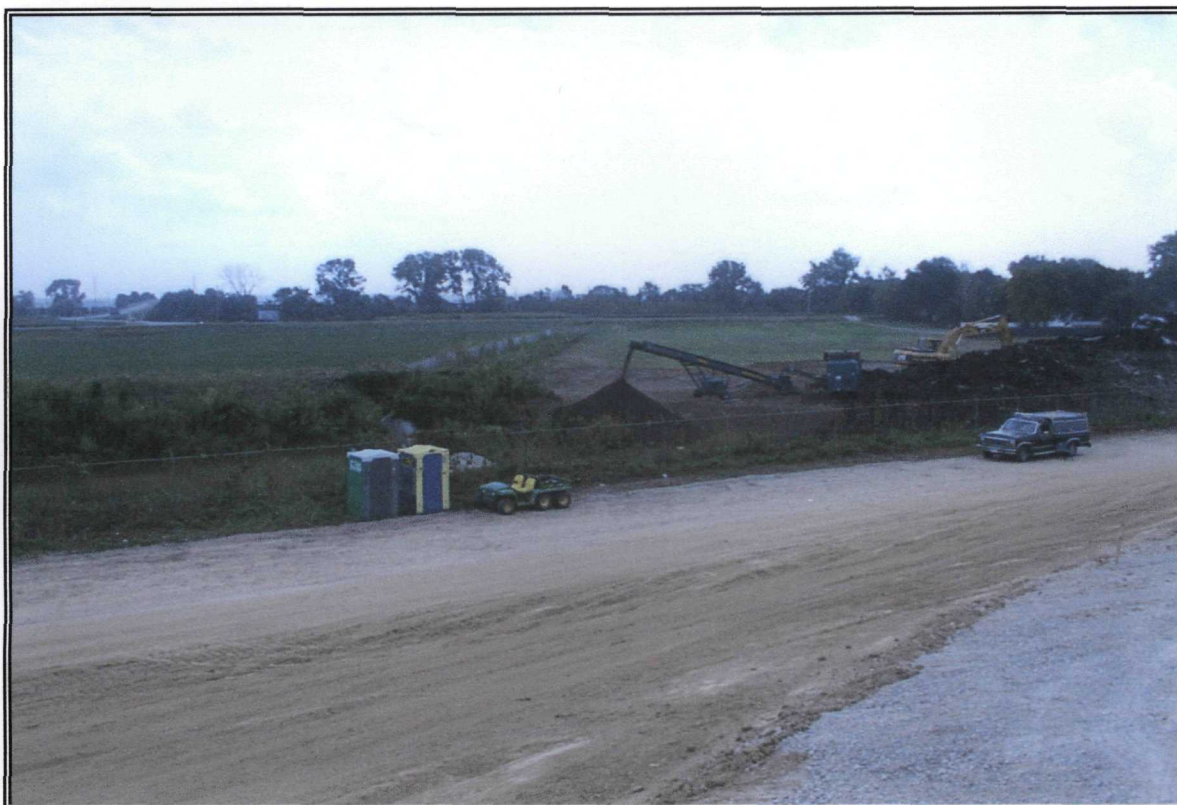
OFFICIAL PHOTOGRAPH NO. 29
U.S. ENVIRONMENTAL PROTECTION AGENCY

Subject: Screening sediment that is stockpiled in Segment B.

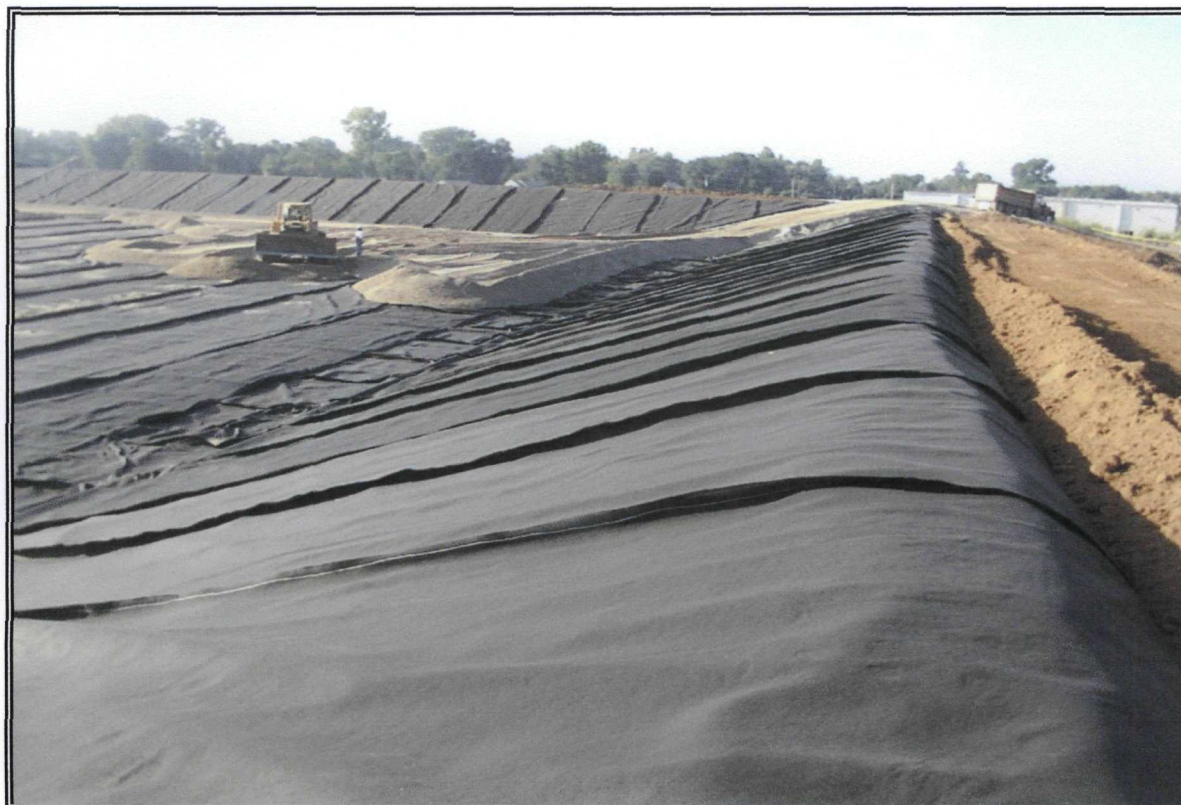
OFFICIAL PHOTOGRAPH NO. 30
U.S. ENVIRONMENTAL PROTECTION AGENCY

Subject: Placing sand on top of the primary liner and securing the anchor trench on the west slope of the cell.

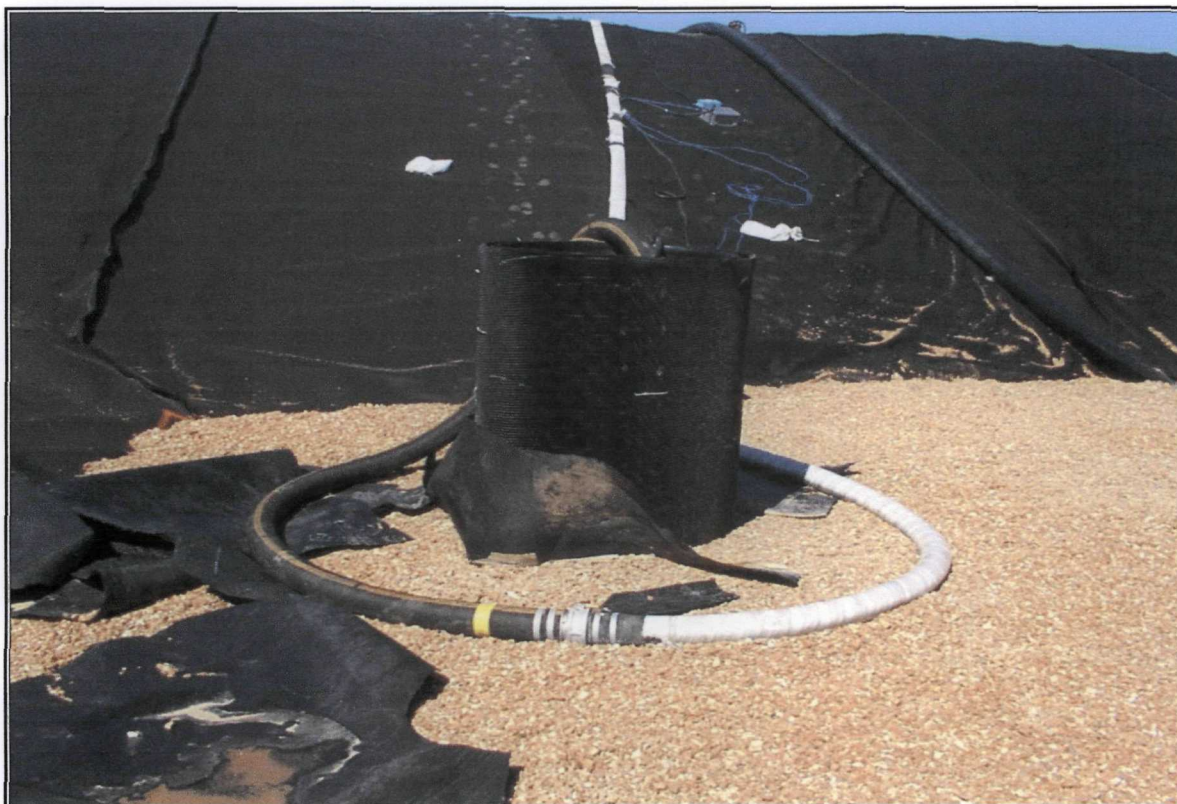
OFFICIAL PHOTOGRAPH NO. 31
U.S. ENVIRONMENTAL PROTECTION AGENCY

Subject: Collection sump located in the northwest corner of the cell.

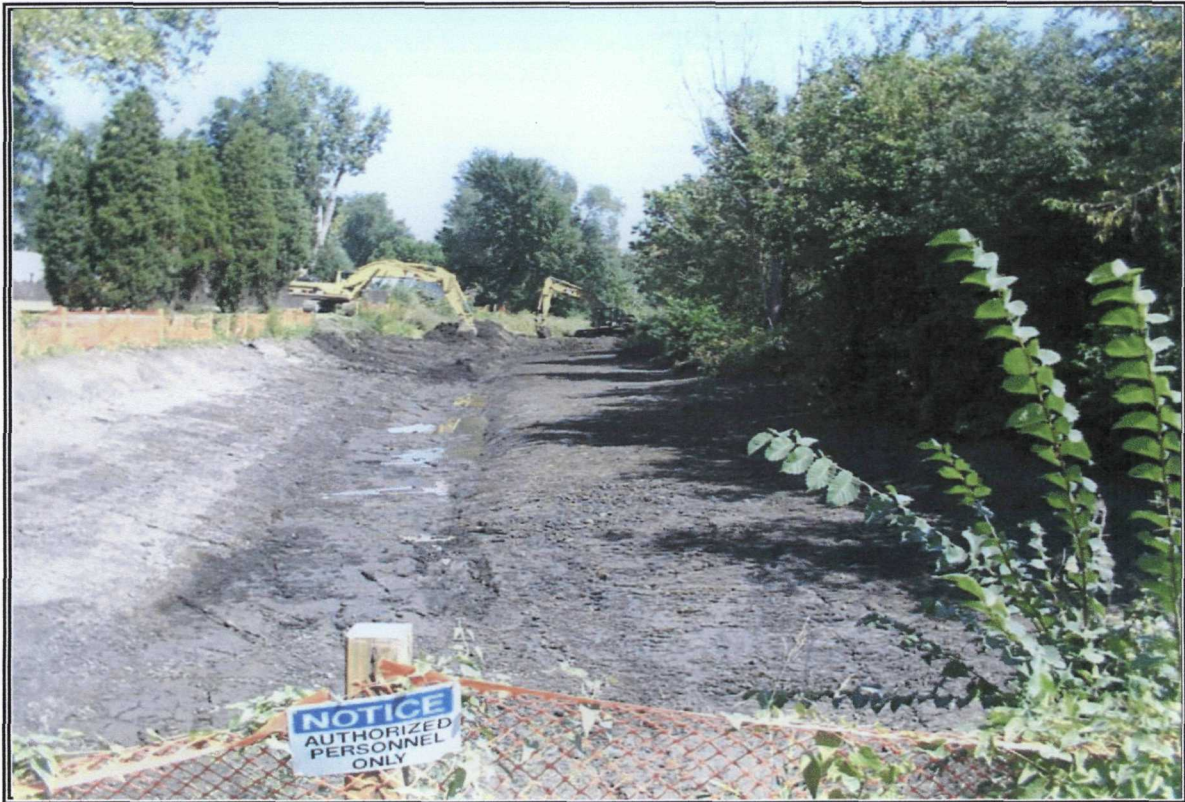
OFFICIAL PHOTOGRAPH NO. 32
U.S. ENVIRONMENTAL PROTECTION AGENCY

Subject: Removal activities in Segment E between Edgar Street and Jerome Lane.

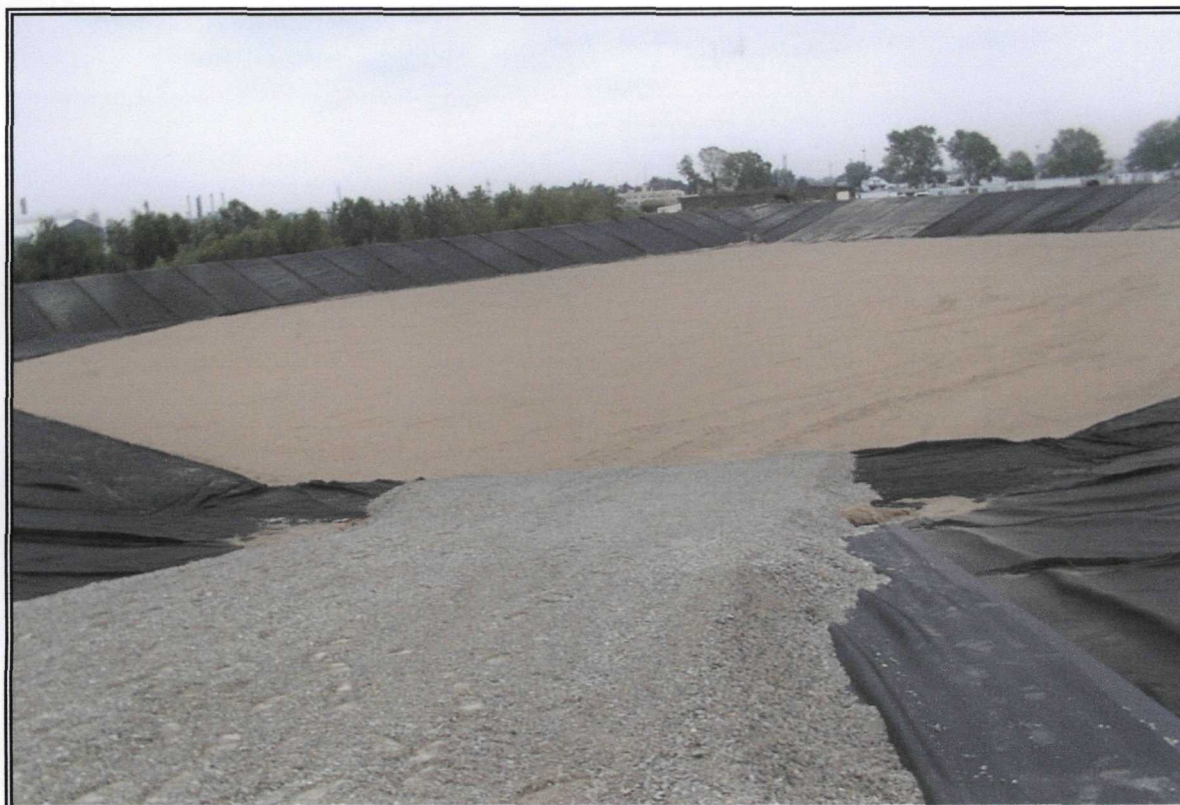
OFFICIAL PHOTOGRAPH NO. 33
U.S. ENVIRONMENTAL PROTECTION AGENCY

Subject: Completed sand layer on top of the liner.

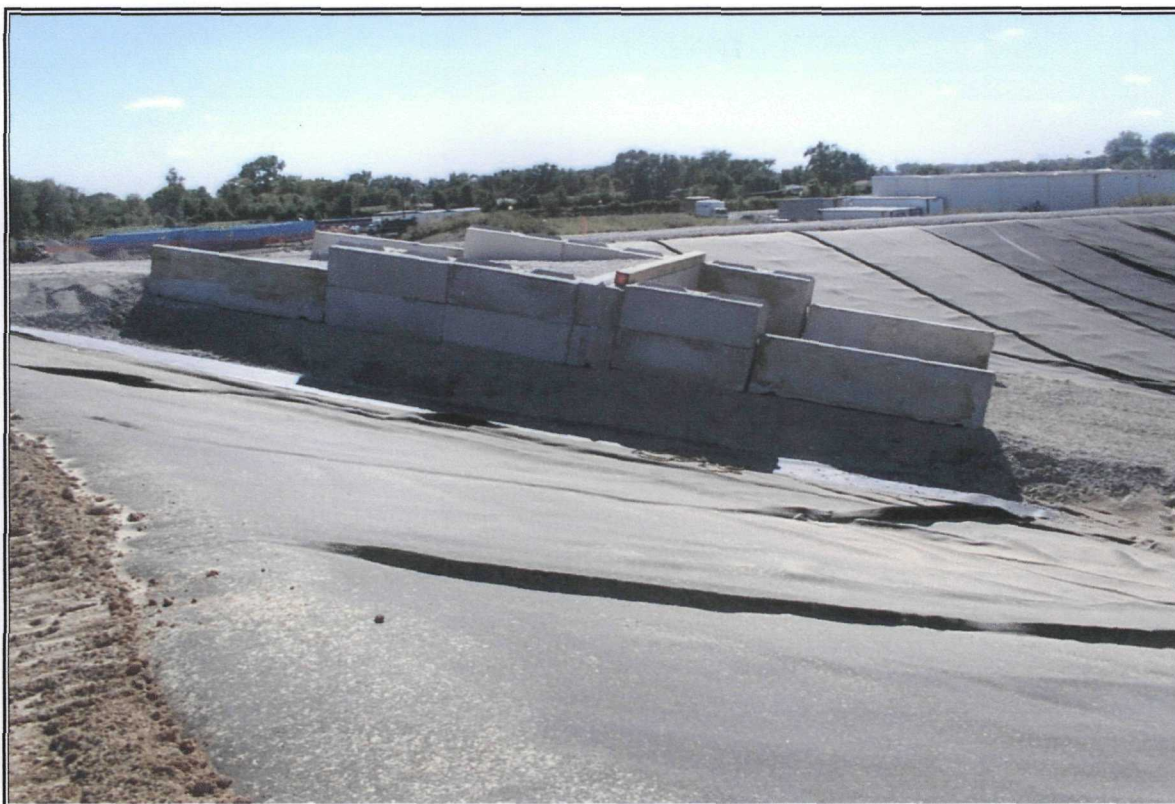
OFFICIAL PHOTOGRAPH NO. 34
U.S. ENVIRONMENTAL PROTECTION AGENCY

Subject: Access ramp on the southeast corner of the cell.

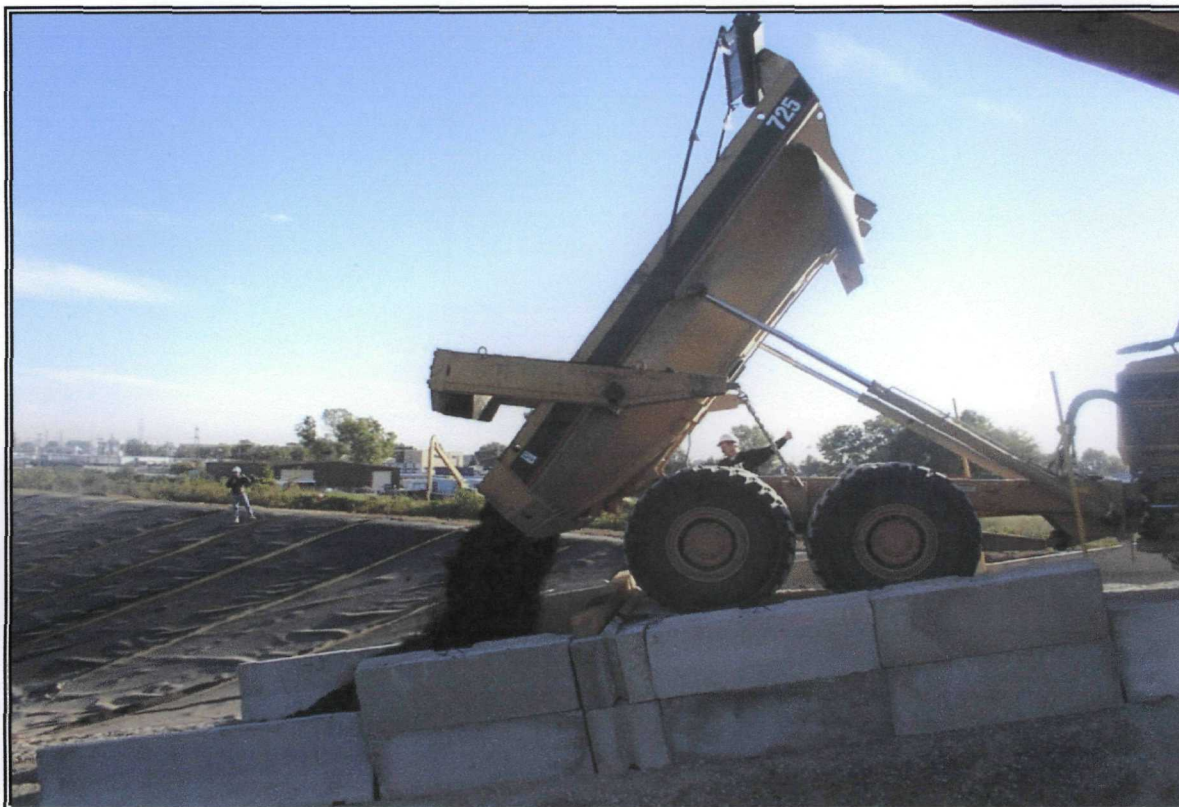
OFFICIAL PHOTOGRAPH NO. 35
U.S. ENVIRONMENTAL PROTECTION AGENCY

Subject: First load of screened sediment is dumped into the cell from the southeast ramp.

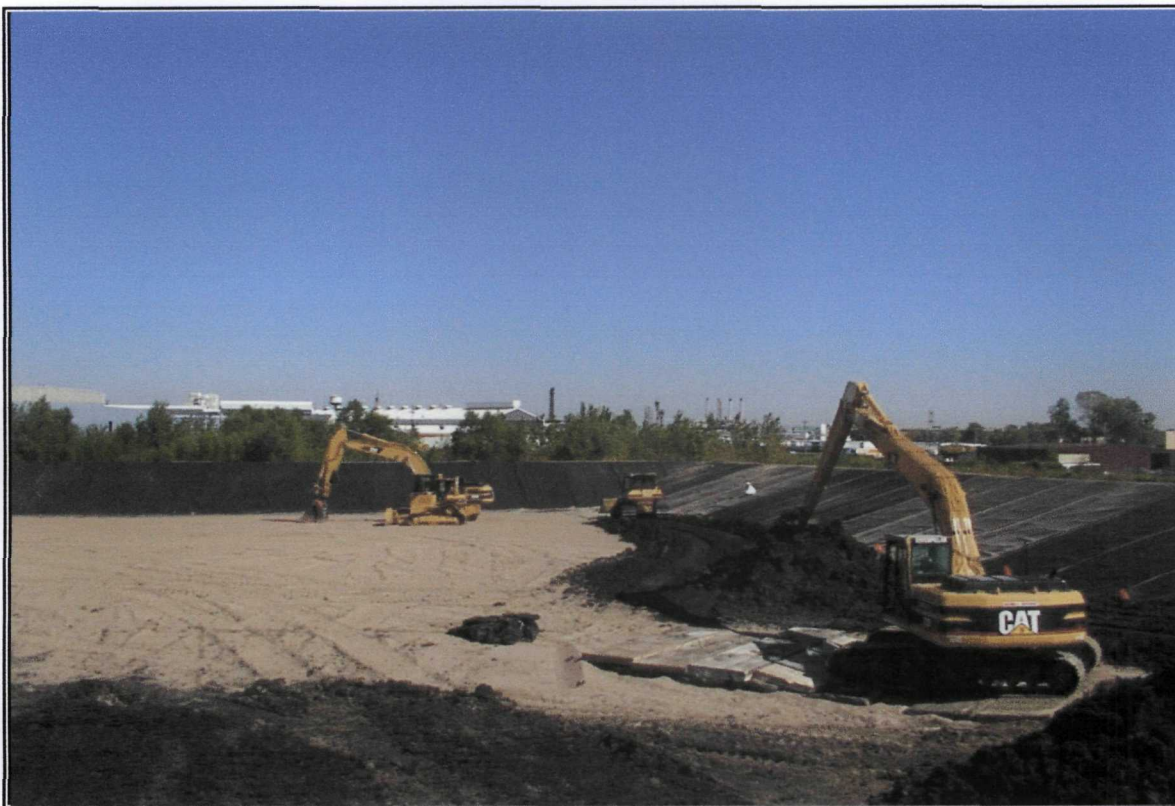
OFFICIAL PHOTOGRAPH NO. 36
U.S. ENVIRONMENTAL PROTECTION AGENCY

Subject: Placing sediment along the toe of the east slope of the cell.

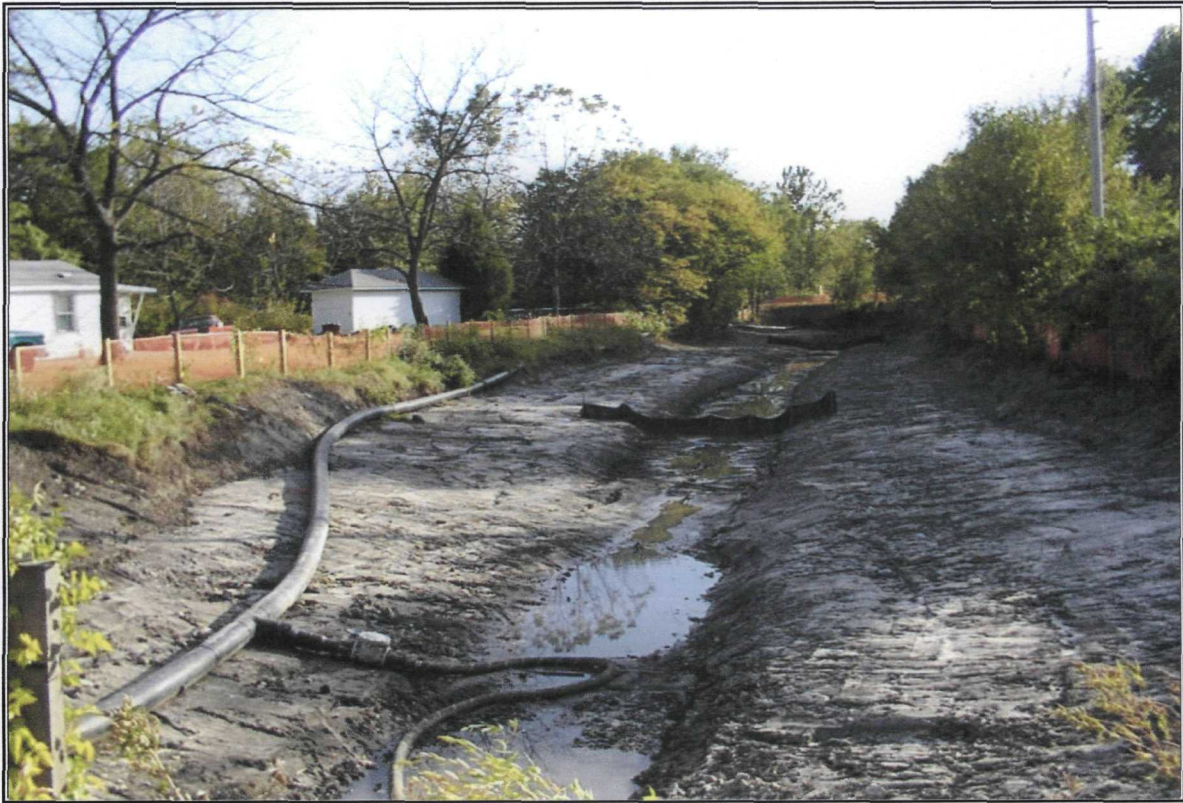
OFFICIAL PHOTOGRAPH NO. 37
U.S. ENVIRONMENTAL PROTECTION AGENCY

Subject: Completed removal in Segment E north of Kinder Street.

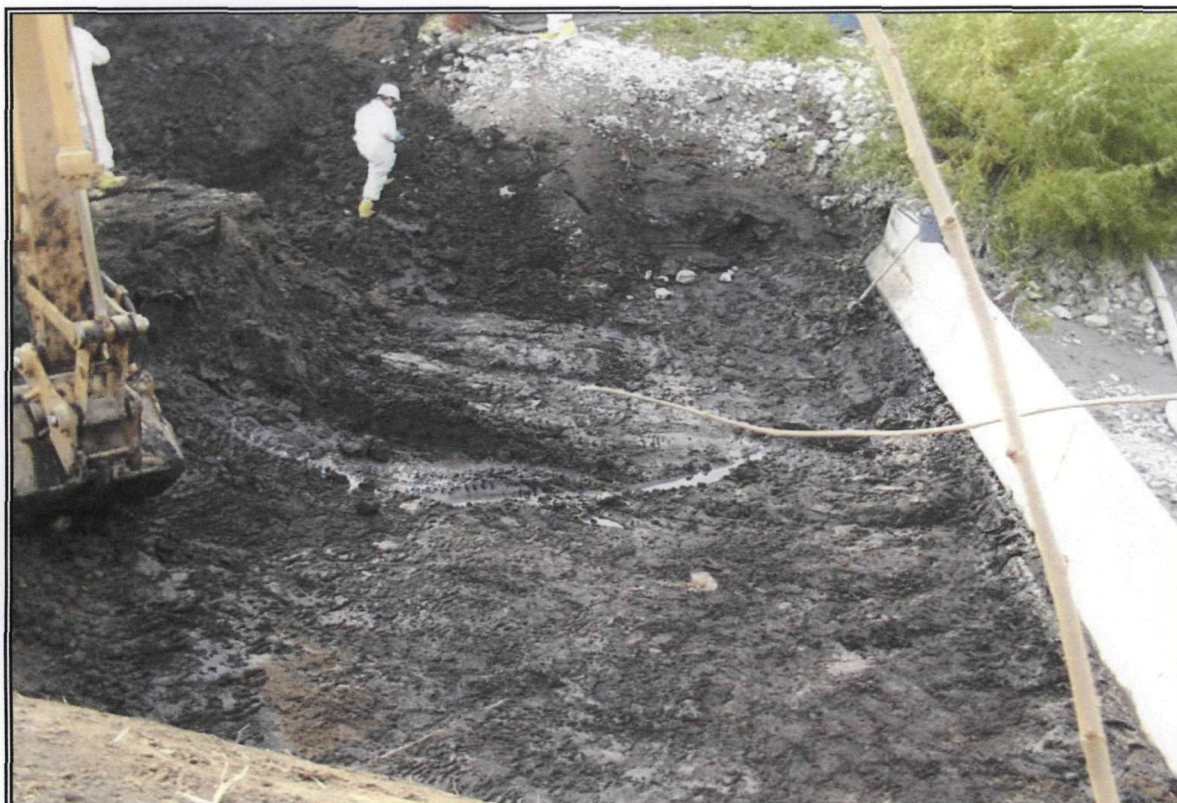
OFFICIAL PHOTOGRAPH NO. 38
U.S. ENVIRONMENTAL PROTECTION AGENCY

Subject: Excavation of Segment B adjacent to Queeny Avenue.

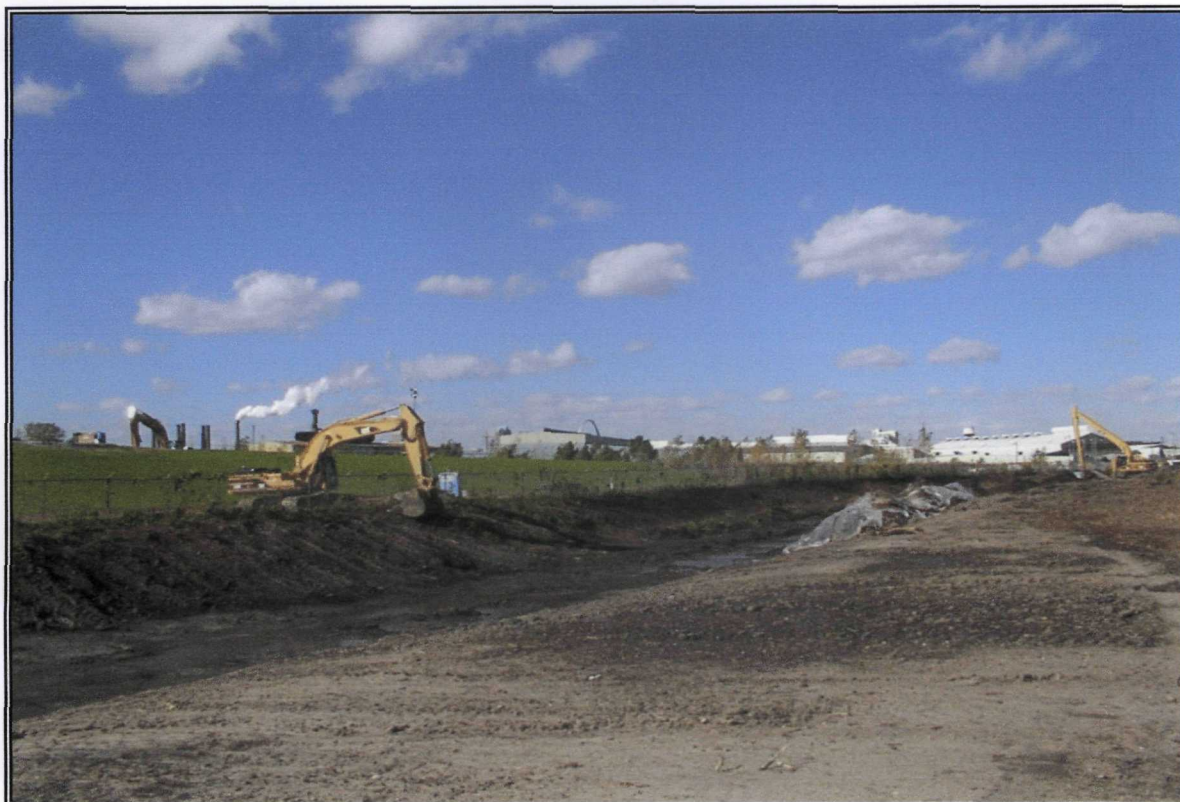
OFFICIAL PHOTOGRAPH NO. 39
U.S. ENVIRONMENTAL PROTECTION AGENCY

Subject: Removal of stockpiled material from Segment B.

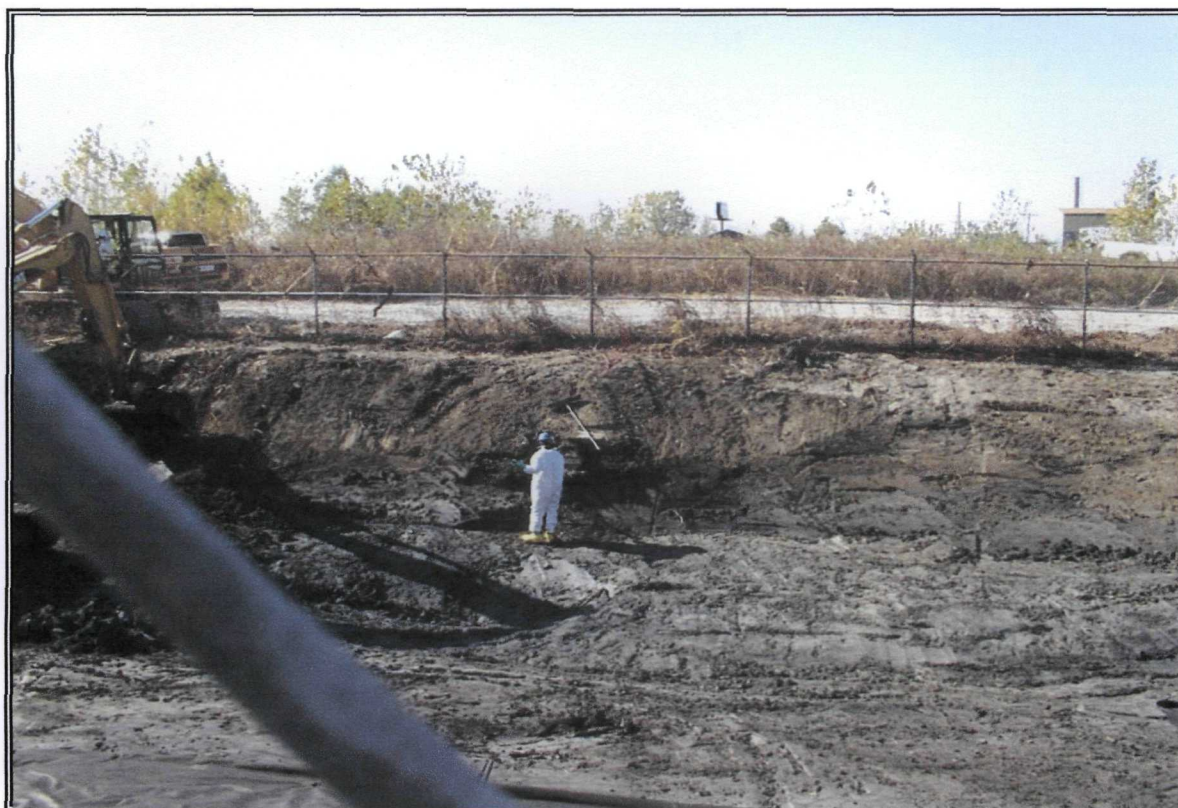
OFFICIAL PHOTOGRAPH NO. 40
U.S. ENVIRONMENTAL PROTECTION AGENCY

Subject: Technician removing material from around the "overflow" pipe located in the west slope of Segment B just south of Queeny Avenue.

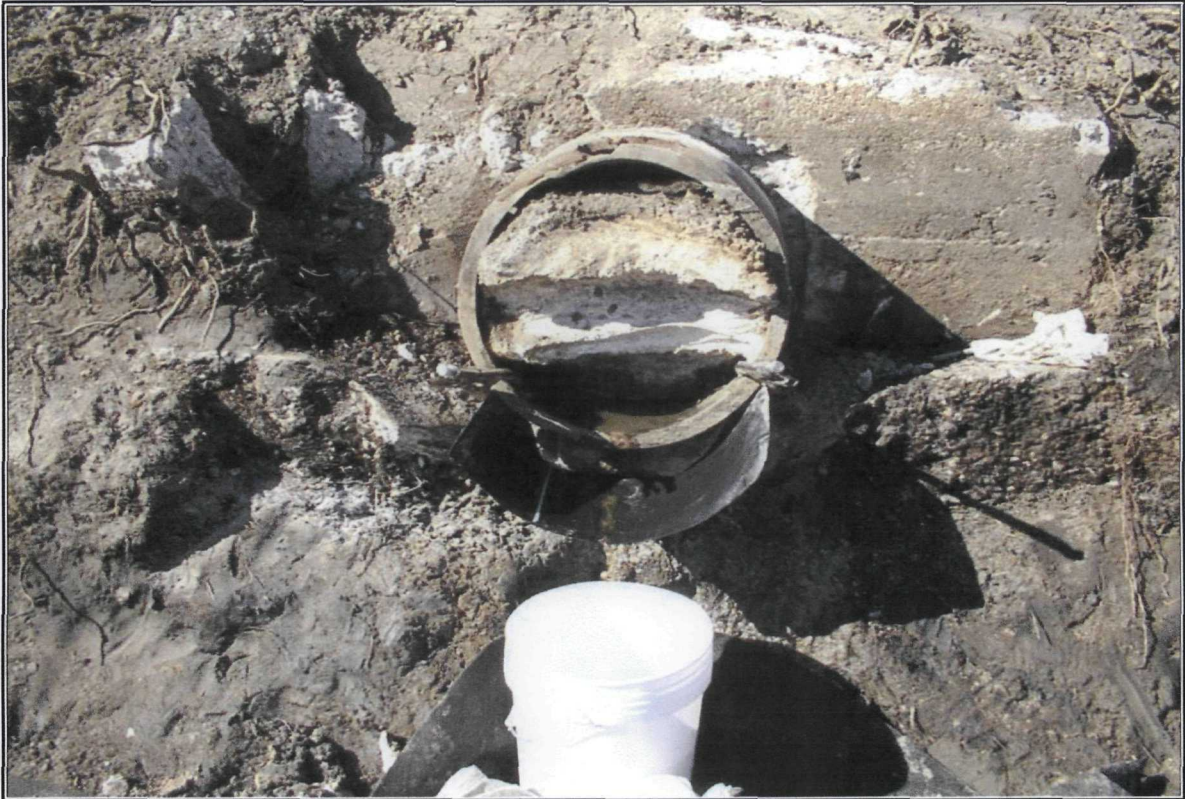
OFFICIAL PHOTOGRAPH NO. 42
U.S. ENVIRONMENTAL PROTECTION AGENCY

Subject: Collecting a sample of the discharge from the "overflow" pipe.

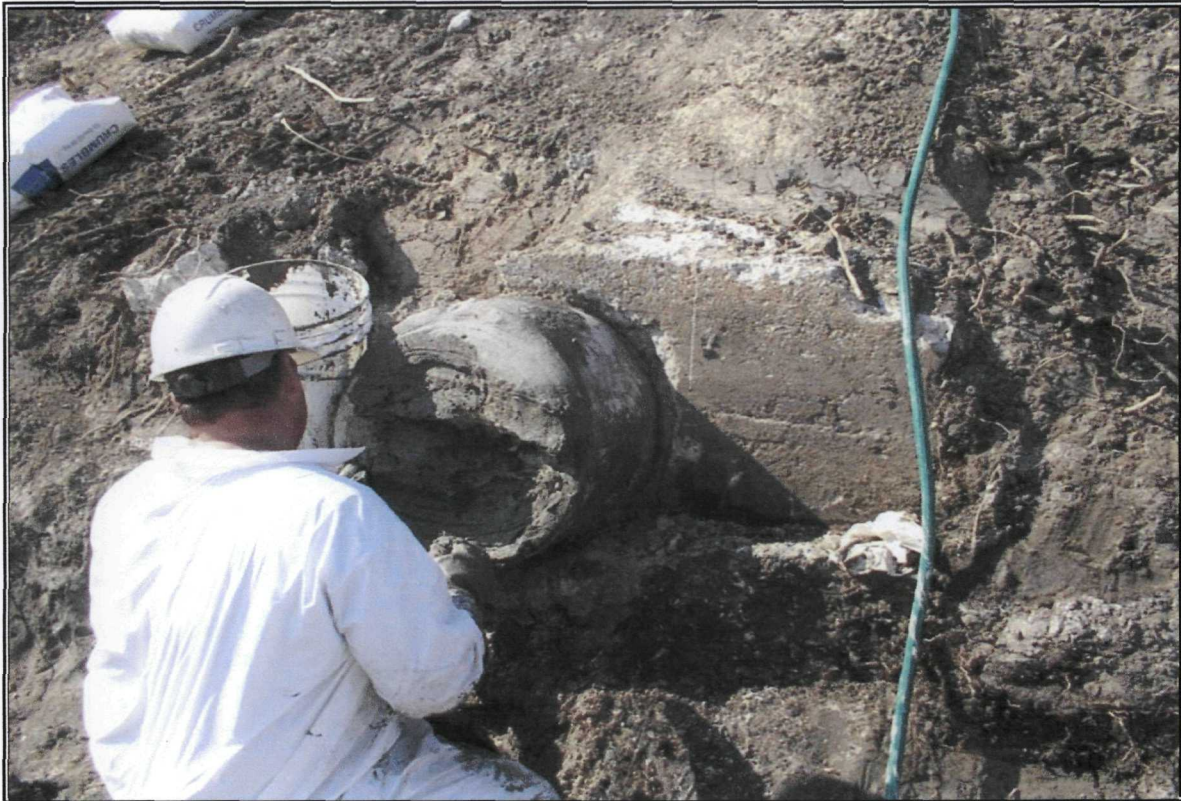
OFFICIAL PHOTOGRAPH NO. 43
U.S. ENVIRONMENTAL PROTECTION AGENCY

Subject: Installation of concrete and bentonite plug in the mouth of the "overflow" pipe.

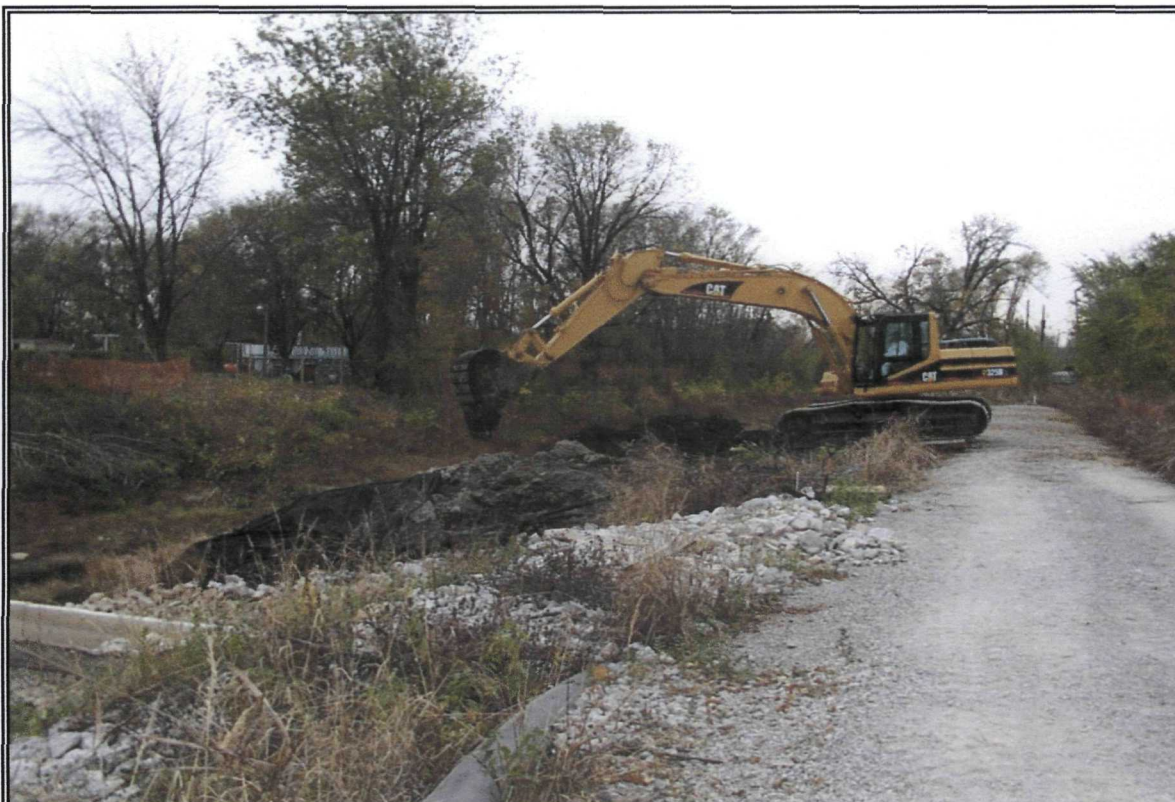
OFFICIAL PHOTOGRAPH NO. 44
U.S. ENVIRONMENTAL PROTECTION AGENCY

Subject: Sediment removal from Segment C just south of Judith Lane.

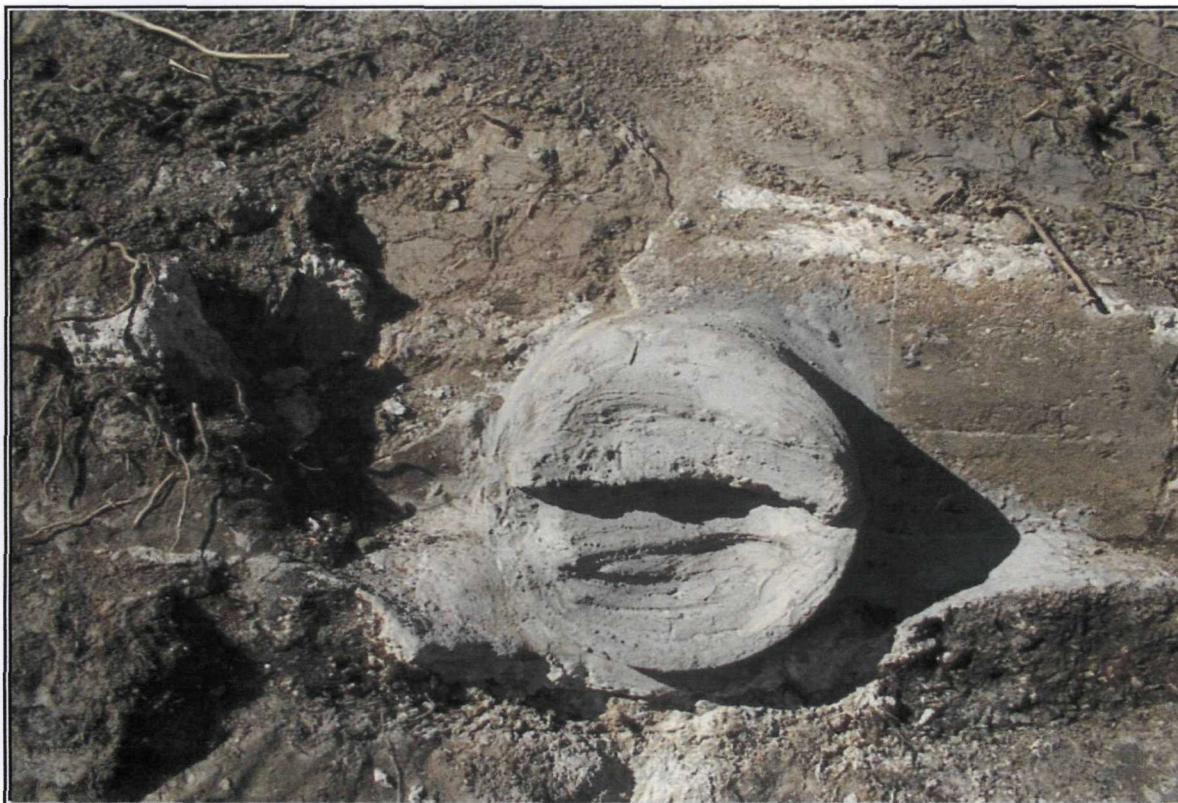
OFFICIAL PHOTOGRAPH NO. 45
U.S. ENVIRONMENTAL PROTECTION AGENCY

Subject: Completed plug in the mouth of the "overflow" pipe.

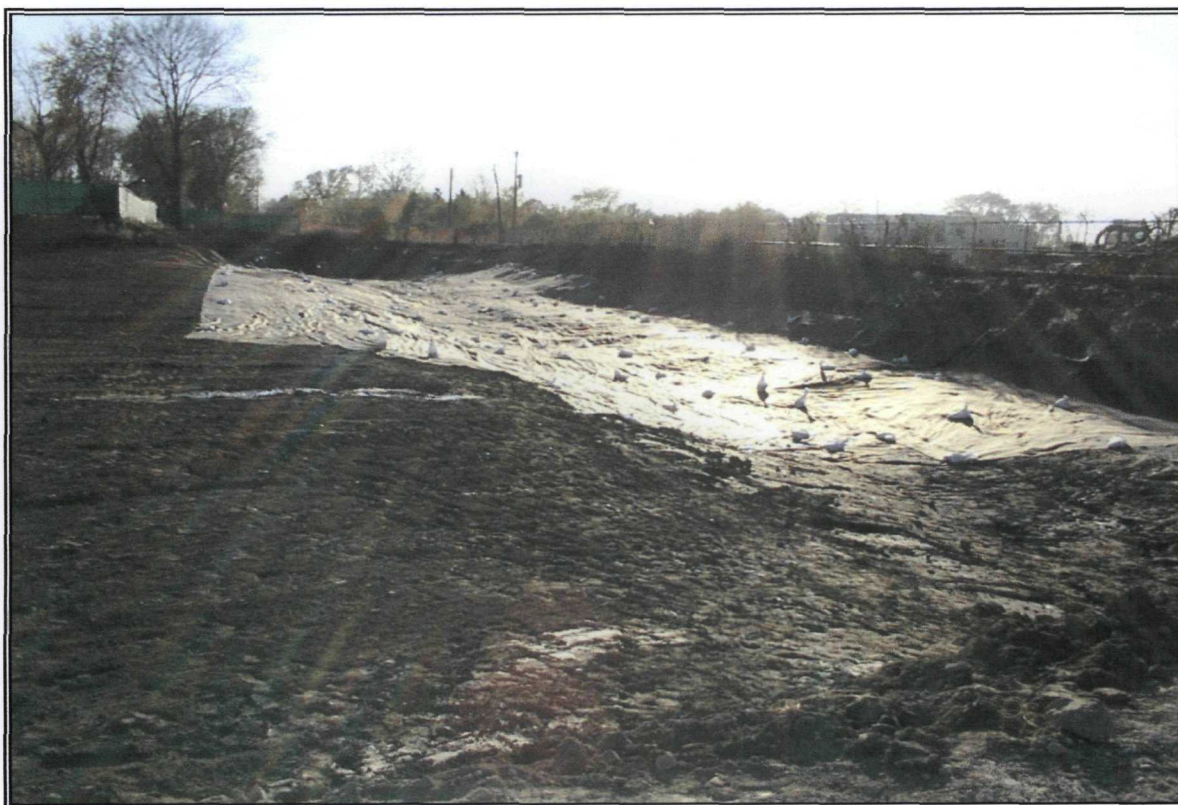
OFFICIAL PHOTOGRAPH NO. 46
U.S. ENVIRONMENTAL PROTECTION AGENCY

<u>Subject:</u>	<u>Southern portion of Segment B with geotextile blanket installed.</u>		
<u>Location:</u>	<u>Dead Creek Sediment Removal Site</u> <u>Sauget, St. Clair County, Illinois</u>		
<u>Orientation:</u>	<u>South</u>		
<u>TDD Number:</u>	<u>S05-0104-010</u>	<u>Date:</u>	<u>November 9, 2001</u>
<u>Photographer:</u>	<u>Tom Binz, TtEMI</u>	<u>Witness:</u>	<u>None</u>

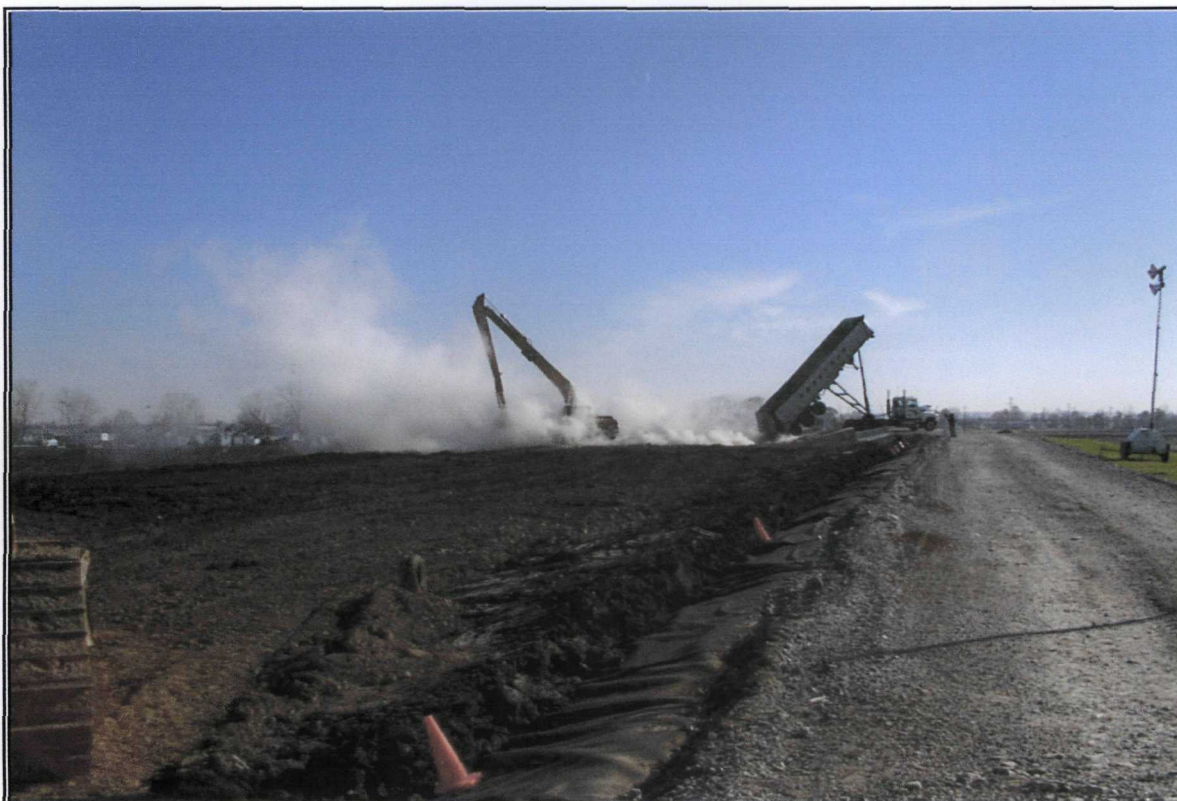
OFFICIAL PHOTOGRAPH NO. 47
U.S. ENVIRONMENTAL PROTECTION AGENCY

Subject: Dumping fly ash in the cell to reduce overall moisture content of material.

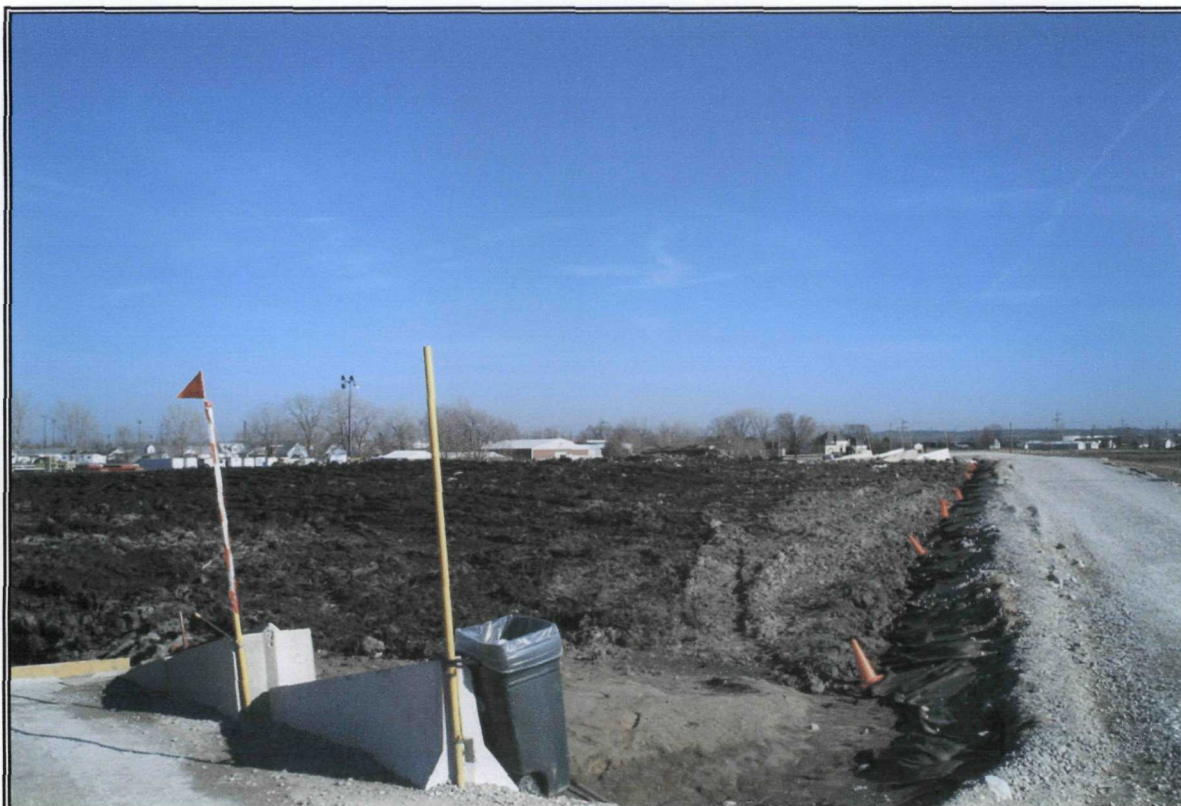
OFFICIAL PHOTOGRAPH NO. 49
U.S. ENVIRONMENTAL PROTECTION AGENCY

Subject: Nearly full cell.

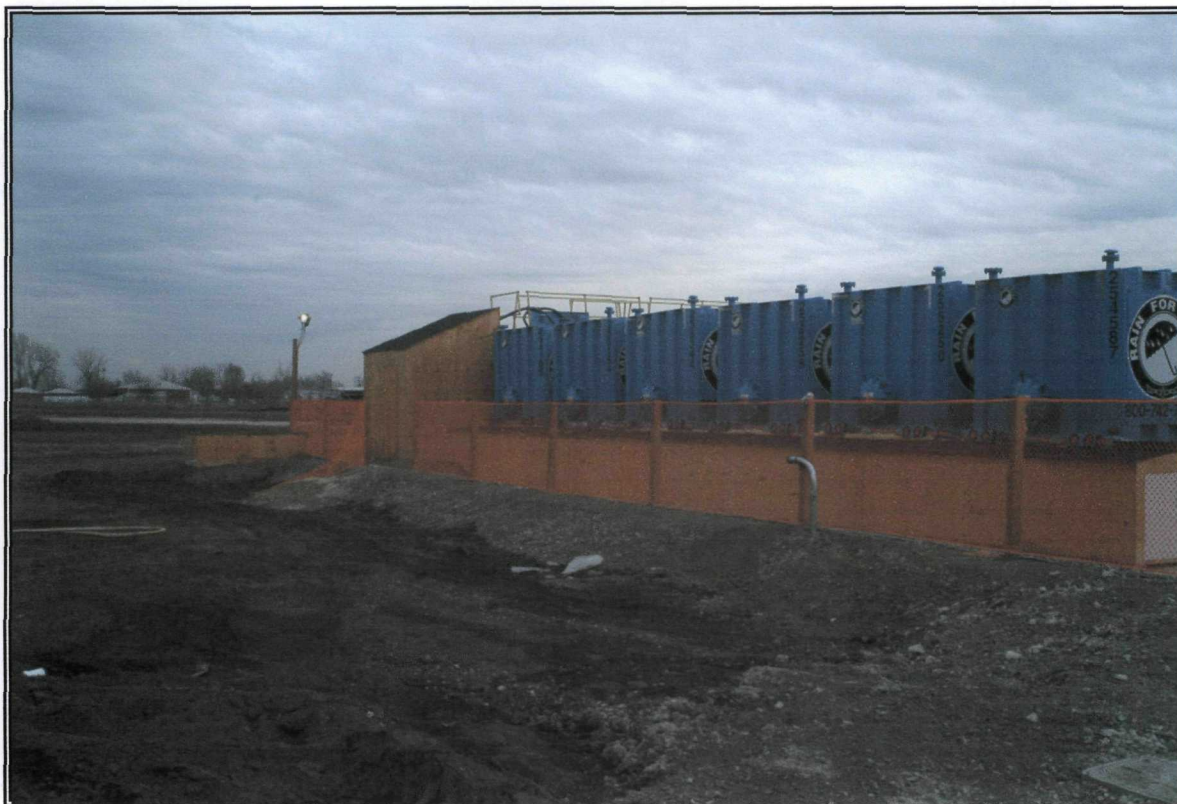
OFFICIAL PHOTOGRAPH NO. 50
U.S. ENVIRONMENTAL PROTECTION AGENCY

Subject: Wastewater treatment system winterization system.
